Docket No. 217 – Development and Management Plan Inspection

Northeast Utilities Service Company Certificate of Environmental Compatibility and Public Need for the construction of a 345-kV electric transmission line and reconstruction of an existing 115-kV electric transmission line between Connecticut Light and Power Company's Plumtree Substation in Bethel, through the towns of Redding, Weston, and Wilton, and to the Norwalk Substation in Norwalk, Connecticut.

Date: October 5, 2005

Location: Transition Stations: Hoyts Hill, Archers Lane, Norwalk Junction

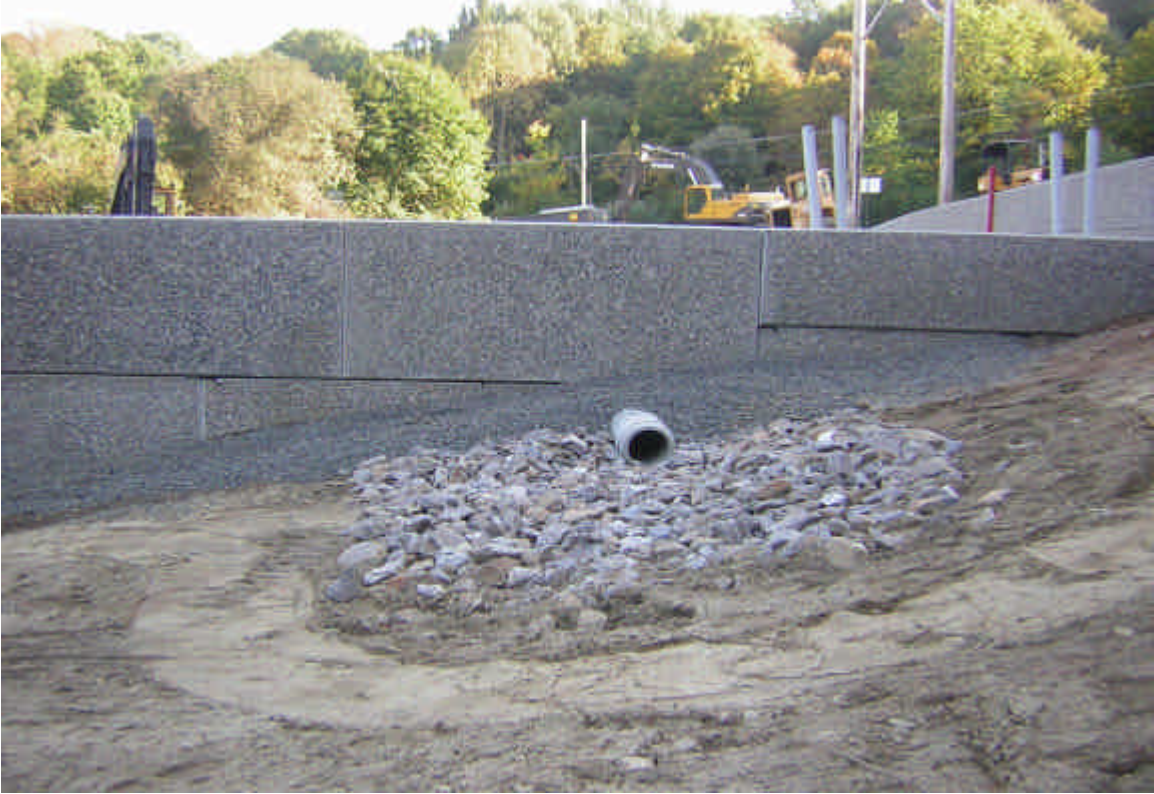
Hoyts Hill Transition Station: View of the outlet of the drain installed at the base of the station retaining wall. A riprap dissipater pad is in place to slow stormwater velocity. (10/5/05)

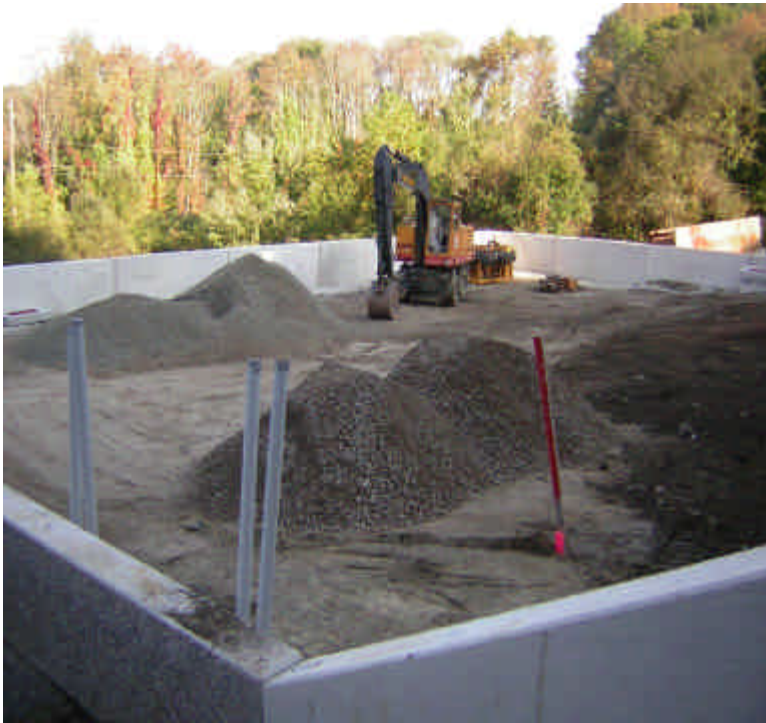
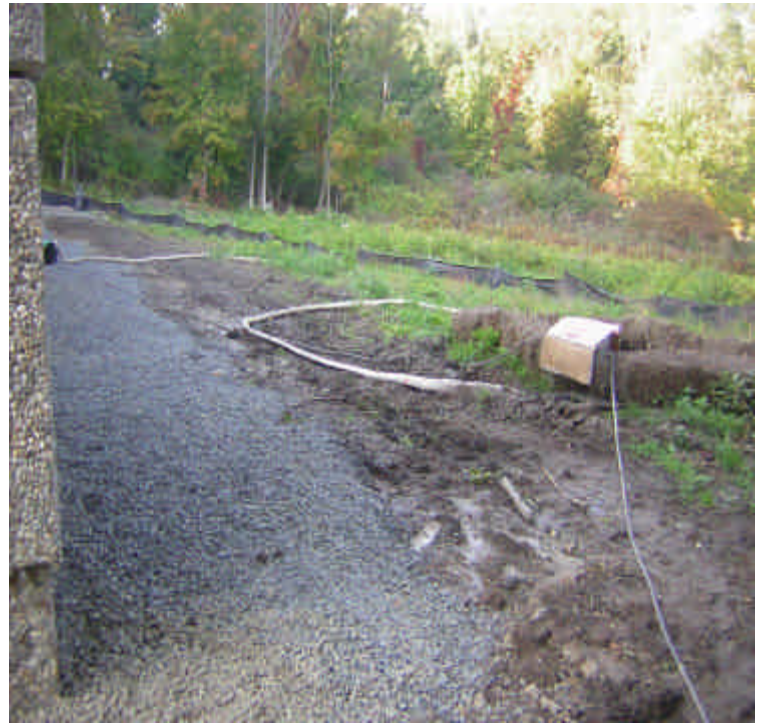
Photo on the left shows an overall view of the station yard and walls. Photo on the right shows where the second line of silt fence was removed as the trench was filled in. (10/5/05)

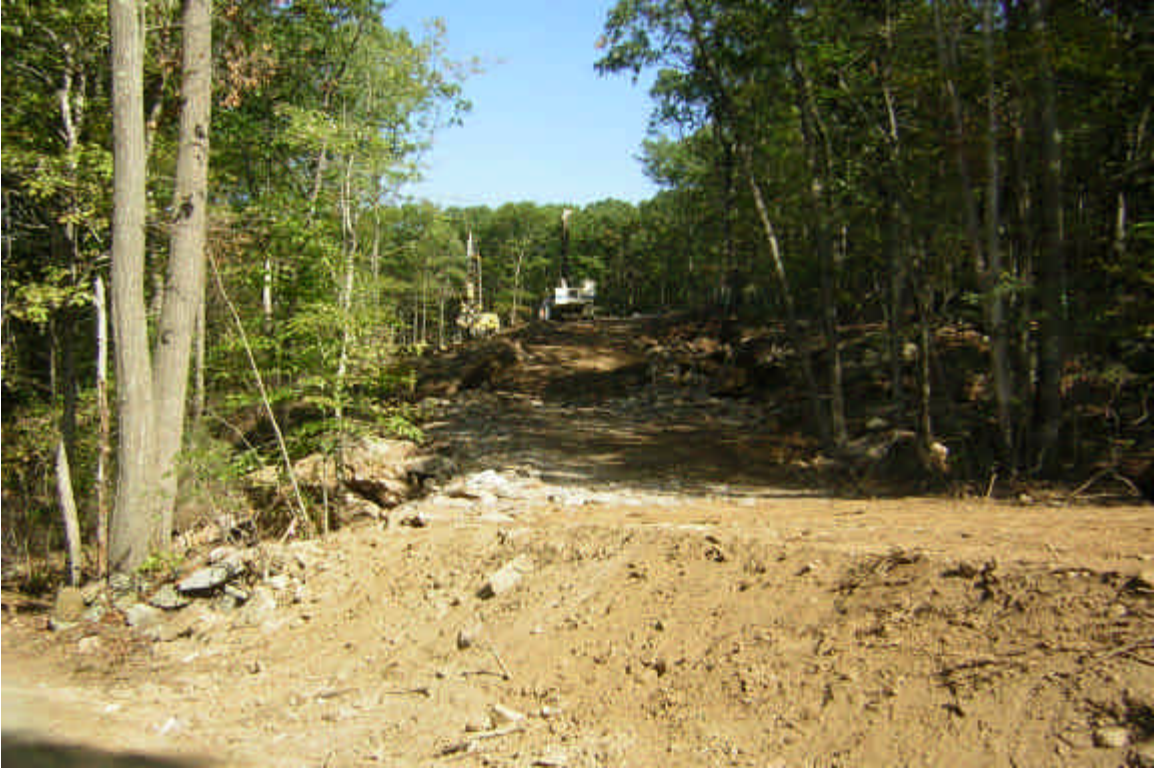
Archers Lane Transition Station: View of the access road into the site where preparation for more blasting was occurring. (10/5/05)

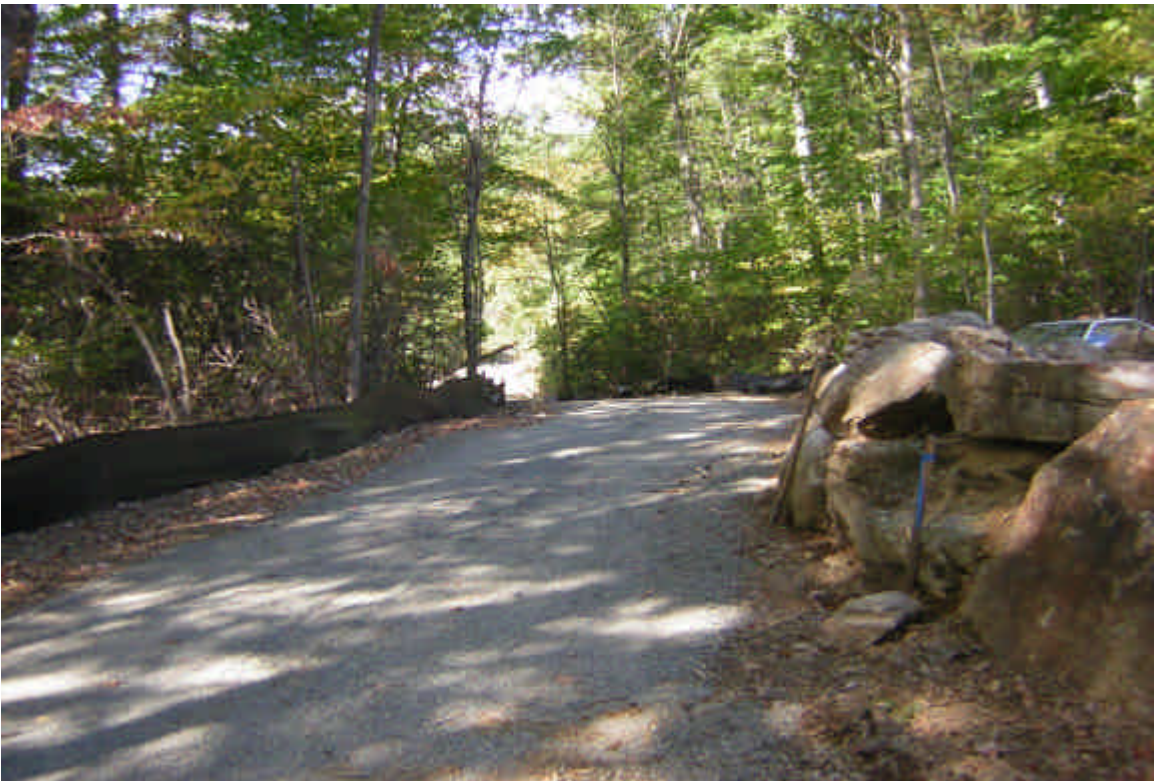
View of the access road leading down to the base of the transition station site and ROW. (10/5/05)

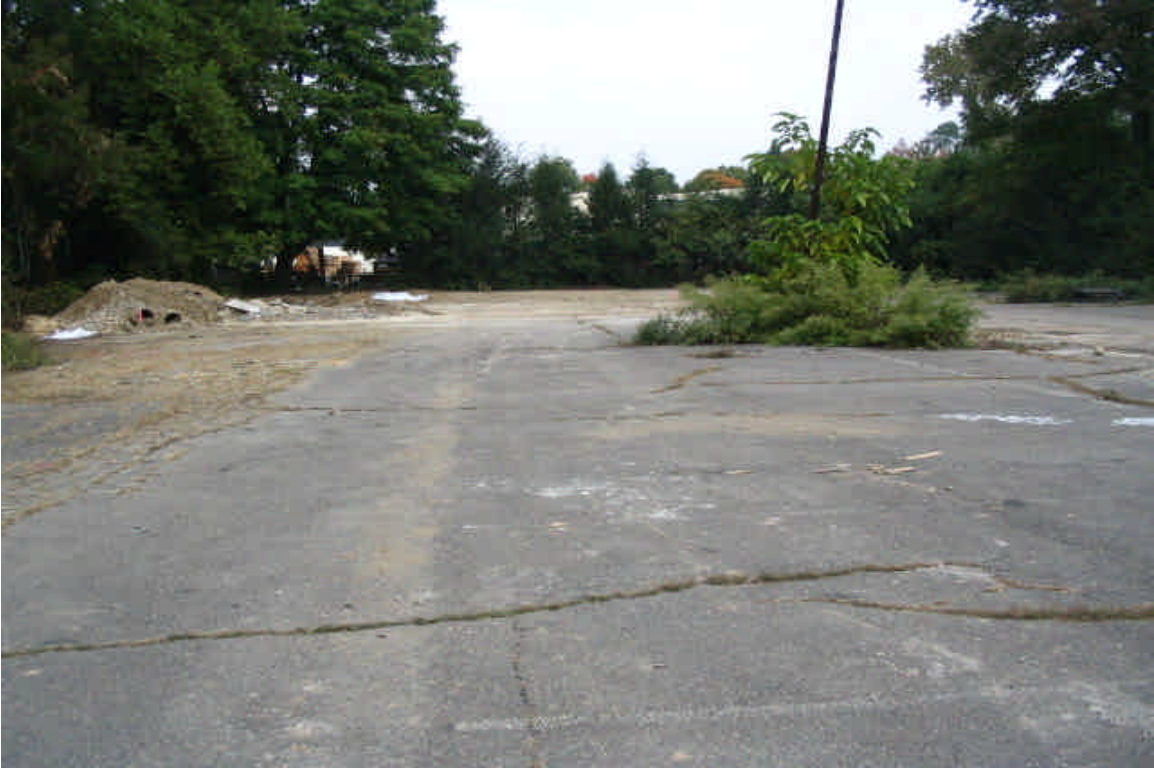
Norwalk Junction Transition Station: View of the lot to be used for the transition station. Asphalt removal will likely begin next week. (10/5/05)

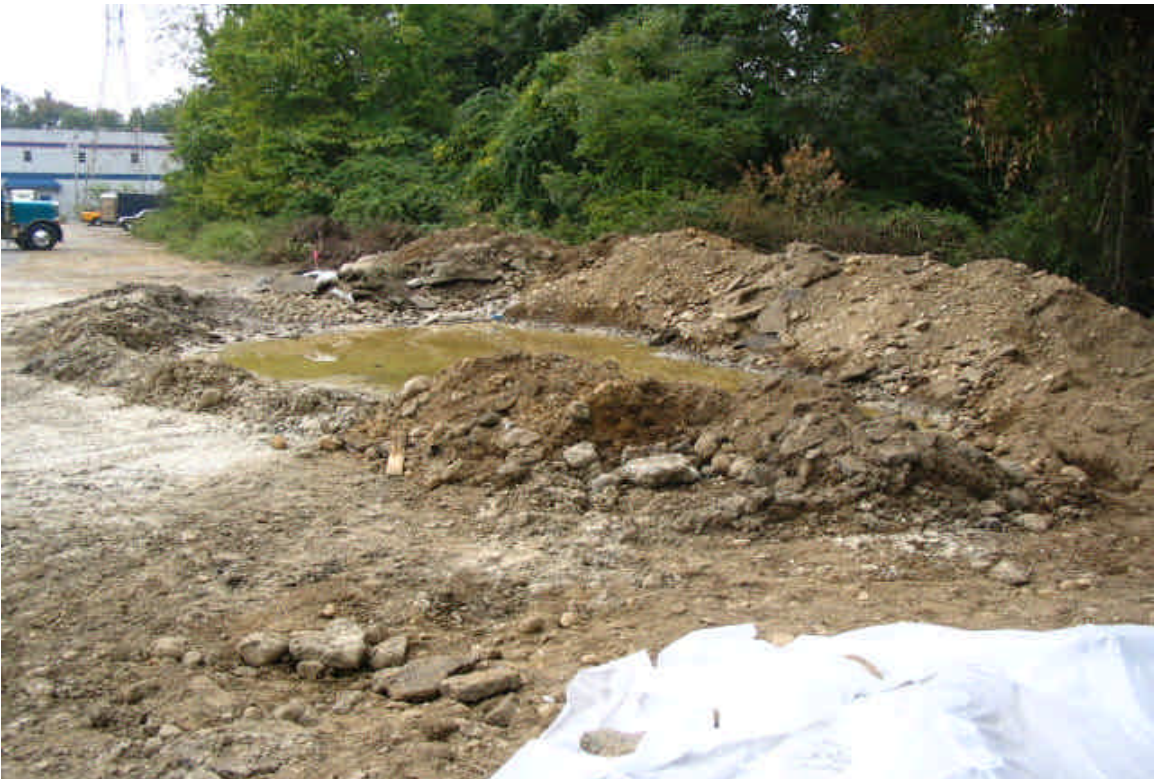
Current work on site is for the 115kV portion of the project. A riser termination structure foundation was installed and the excavate has been stockpiled. Trenching is ongoing to access this structure. (10/5/05)
